# Hawkesbury-Nepean River March 2021 Flood Review

HAWKESBURY-NEPEAN VALLEY FLOOD RISK  
MANAGEMENT STRATEGY

Final Report  
December 2021

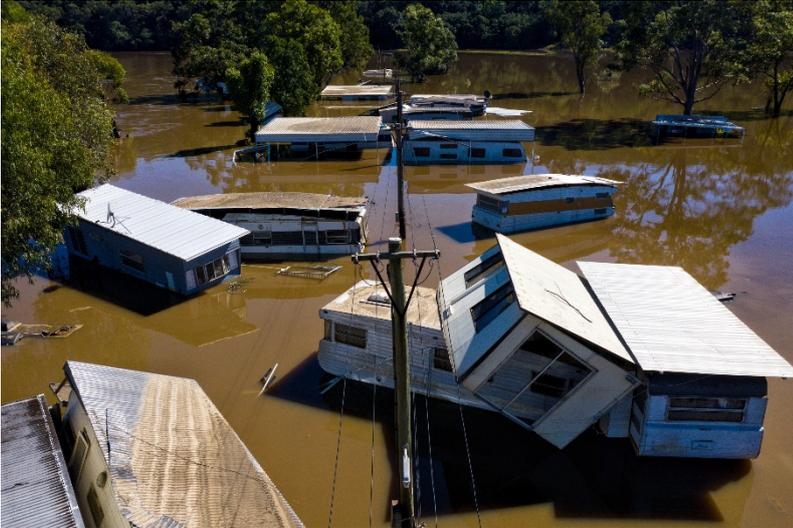
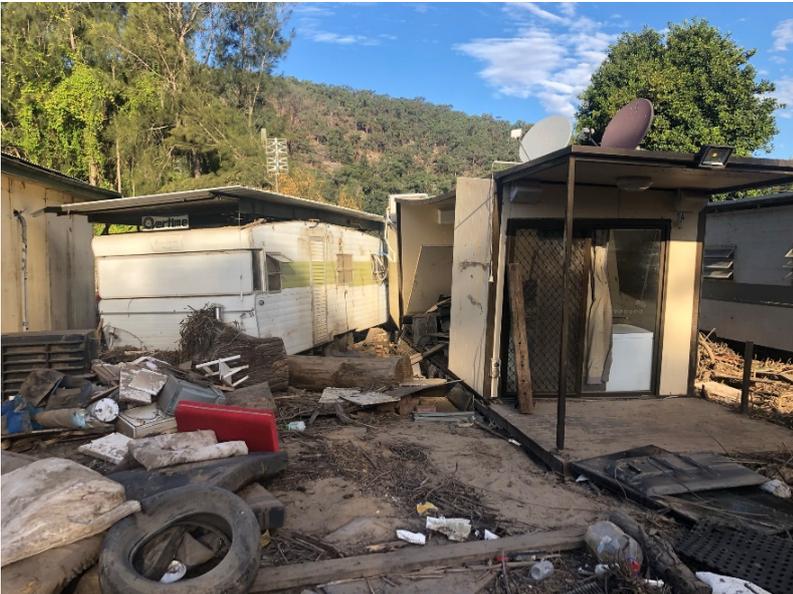
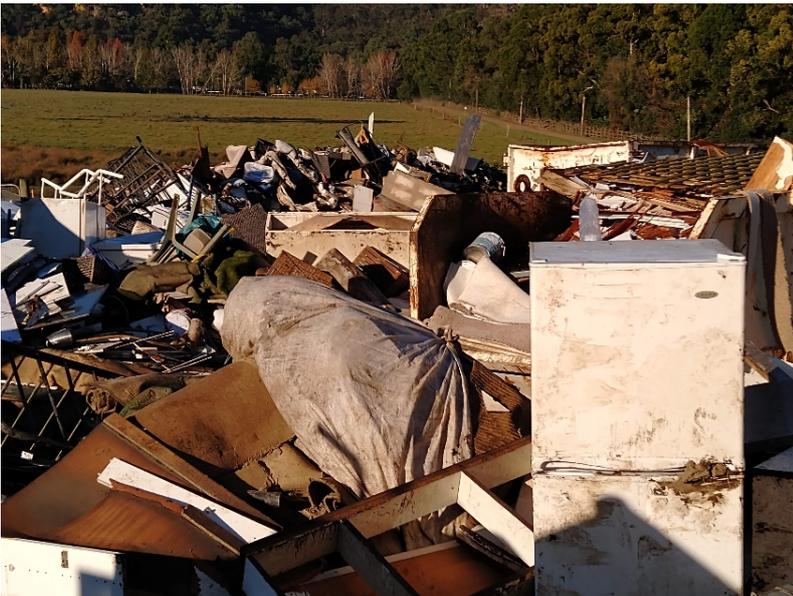
*Figure 27: Damage at caravan parks, Hawkesbury-Nepean, March 2021 flood*

Many of the impacted caravan parks have a large number of manufactured homes (Table 3), which are not easily moved in the time available ahead of forecast flooding. Some of these were shifted off their foundations by the force of the floodwaters and some sustained structural damage to floors and walls. Several caravans floated downstream, some deposited at St George Caravan Park.

Shifted and toppled vans and annexes, Dargle Water Ski Resort, Lower Portland

Shifted van and damaged annexe at St George Caravan Park, Lower Portland

Debris pile from Rosevale Caravan Park, Gunderman

Examples of flood damage are provided in Figure 27. Flood imagery for caravan parks is collated in Appendix E.

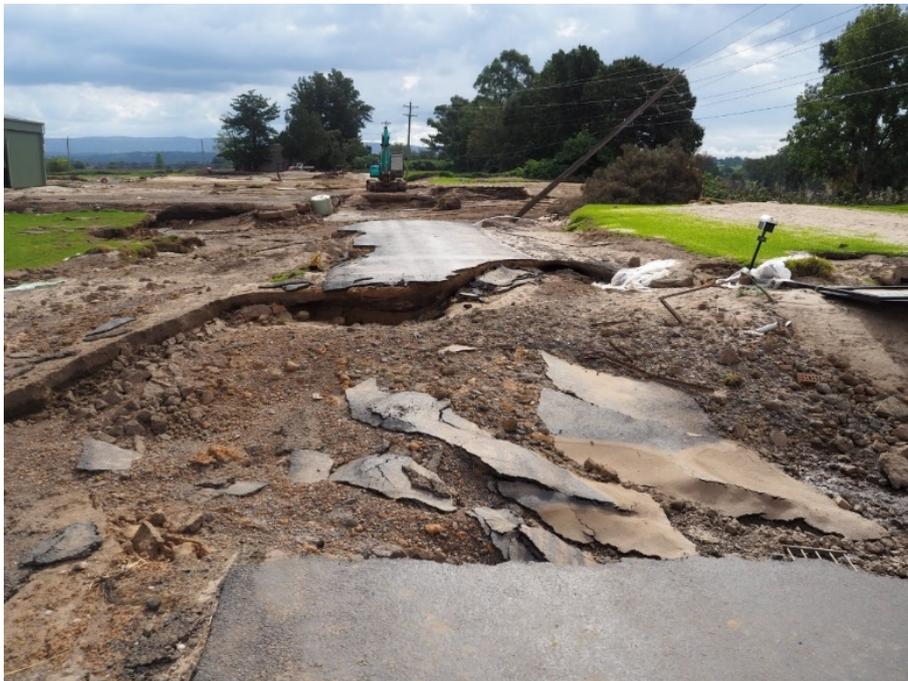
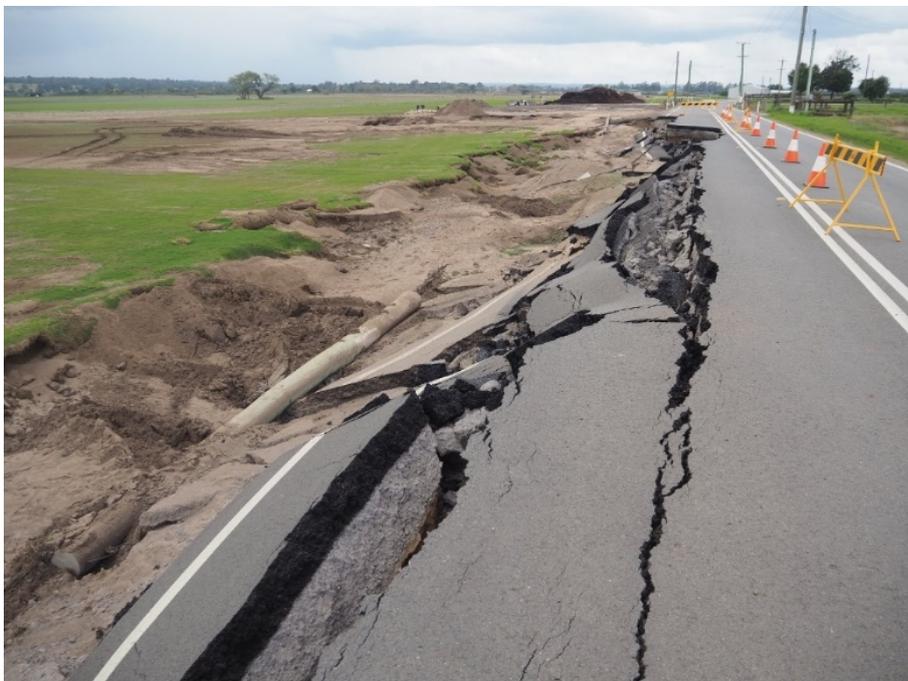
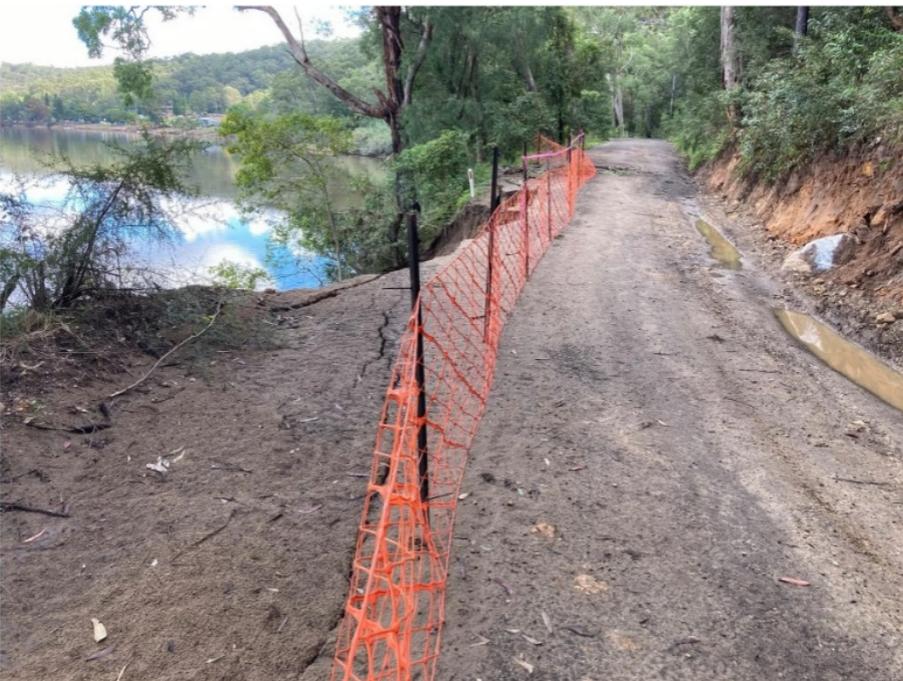
*Figure 29: Damaged local roads, March 2021 flood*

Significant damage was caused to council-owned roads. As of early June, Hawkesbury Council estimated a preliminary damage bill of \$18.5 million to repair council roads. The Hills Council reported damage to road pavements and embankments on Chapel Hill Road, Pages Wharf Road and Mitchells Road in Sackville, and potholes throughout the shire.

Cornwallis Road, Cornwallis  
Source: Hawkesbury City Council

Freemans Reach Road,  
Freemans Reach  
Source: Hawkesbury City Council

Greens Road, Lower Portland  
Source: Hawkesbury Post

Examples of severe damage to roads from flooding and riverbank erosion are depicted in Figure 29.

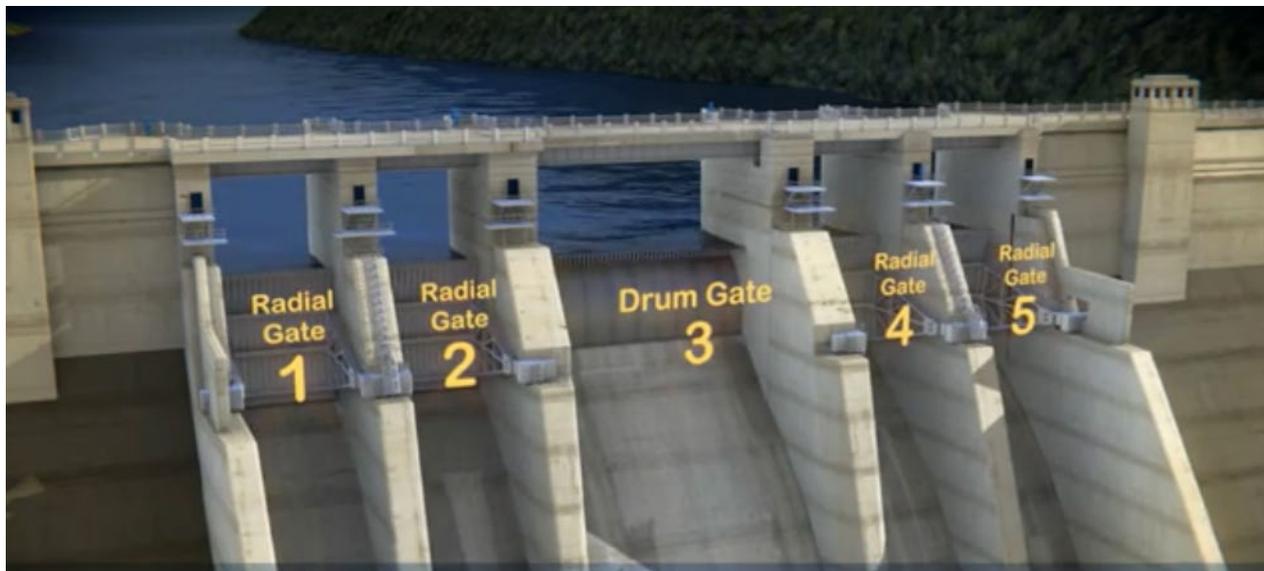
Figure F1. Warragamba Dam central spillway drum and radial gates

Flood inflows to Warragamba Dam storage are discharged from the gated spillway using an automatic system known as the H14 protocol for the drum and radial gates (see Figure F1).
